# GALENA AIRPORT

## 2004 Alaska Airport Pavement Condition Report

# **EDWARD G. PITKA SR. AIRPORT GALENA -2004**

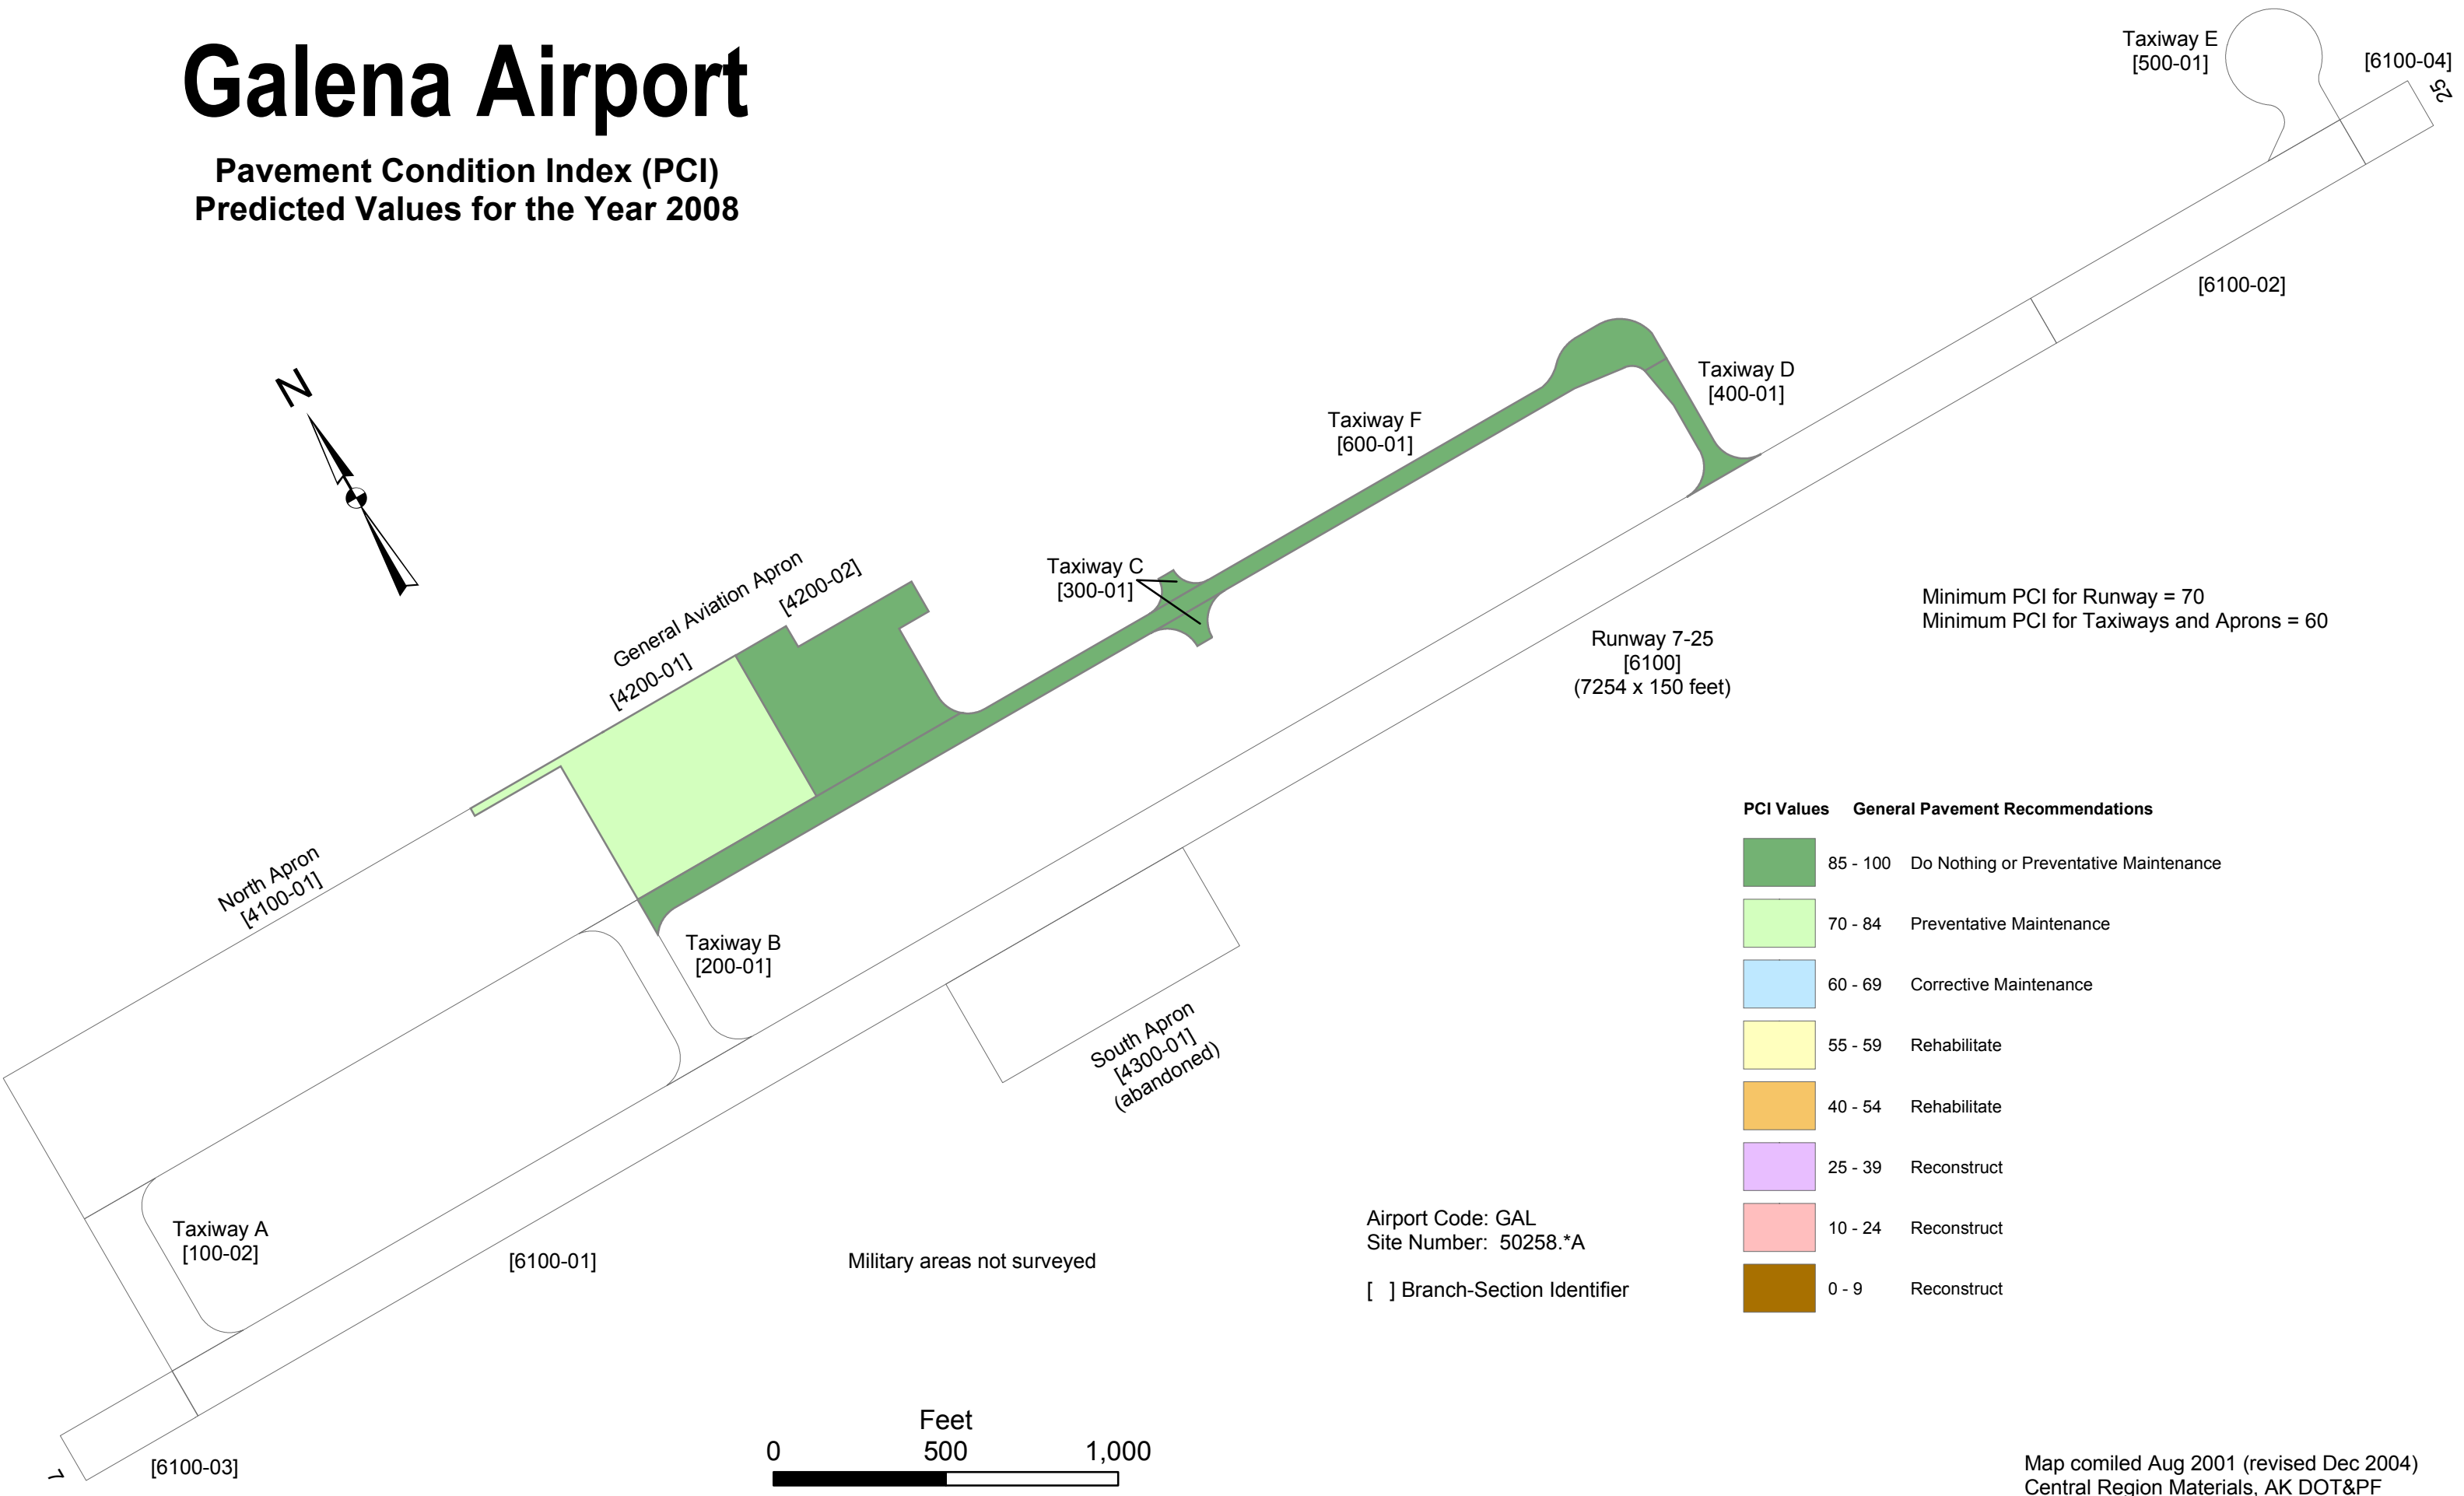
Minimum PCI for Runway = 70  
Minimum PCI for Taxiways and Aprons = 60
